Appearance

Steel Chemistry

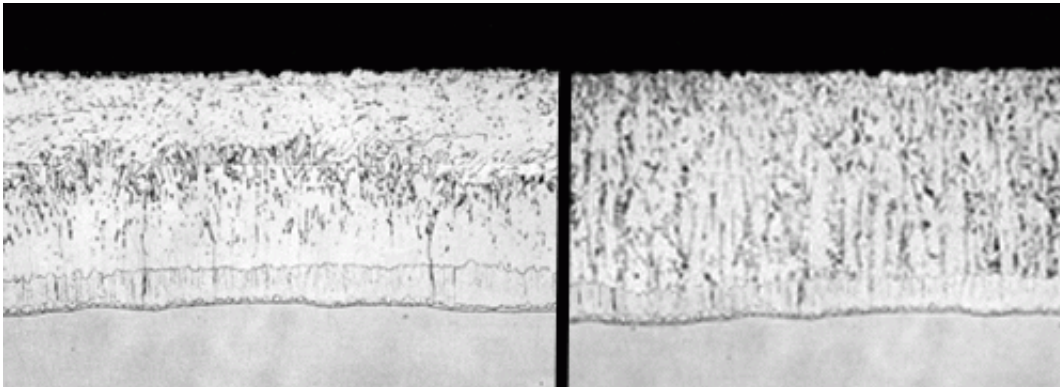
Regular vs. Irregular Zinc-Iron Alloy Layers

Silicon is added during the steel making process to deoxidize it. The recommended silicon composition for steel to be galvanized is either less than 0.04% or between 0.15% and 0.25%. Steels outside these ranges are considered reactive steels and can be expected to form zinc coatings thicker than average. The Sandelin Curve compares the zinc coating thickness to the mass percentage of silicon in the steel.

In addition to producing thicker coatings, highly reactive steels tend to have a matte gray or mottled appearance instead of a typical bright coating. This difference in appearance is a result of the rapid zinc-iron intermetallic growth that consumes the normally bright, pure zinc outer layer. This growth of the intermetallic layer is out of the galvanizers

control; however, if aware of the steel's composition beforehand, the galvanizer can utilize some process controls to minimize the effect. The figures (above) show the differences between the alloy formations on steel with recommended silicon ranges (left) and those of reactive steels (right). Though the appearance and microstructure differ, the increased coating thickness can be beneficial in some respects as the time to first maintenance is linearly related to coating thickness.

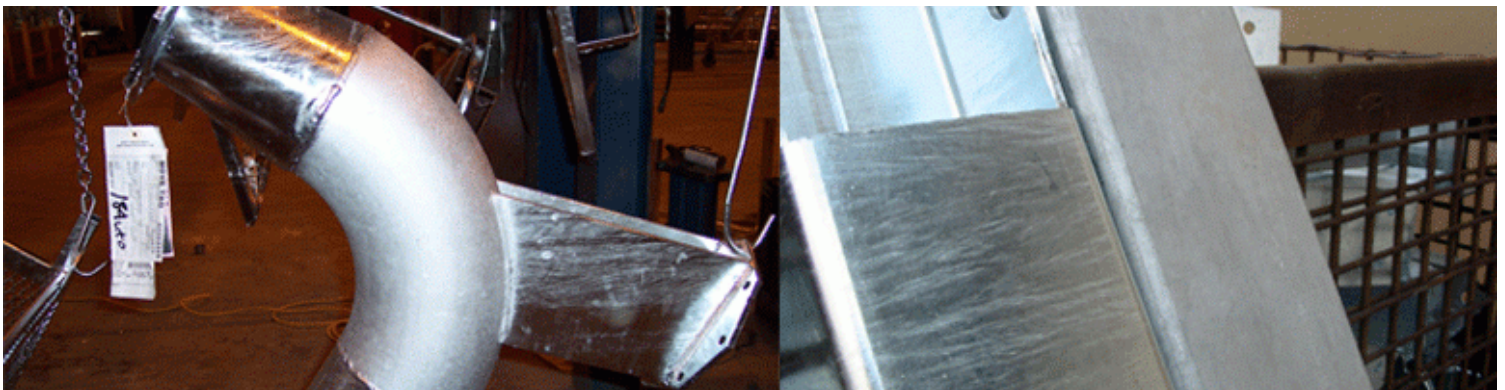
The image (below) shows connected galvanized pieces with different appearances due to steel chemistry. This is often observed when connecting different types or thicknesses of steel, but can also occur on similar pieces. Another common place this is found is in welded areas, as the silicon content of the welding rod can influence appearance. Regardless of the appearance, all of these products have an equal amount of corrosion protection and meet the specification requirements.

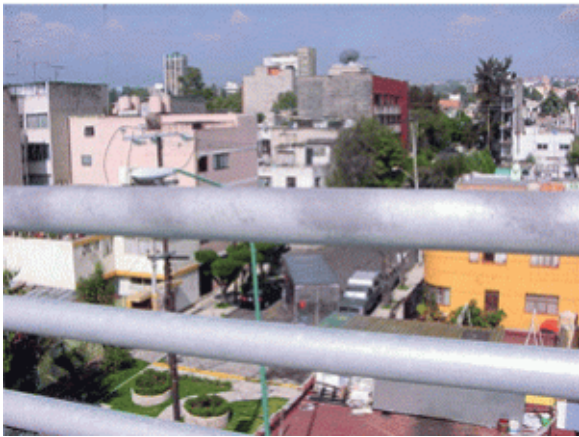
In addition to cooling rates and steel chemistry, the fabrication and processing of the steel can create a bright or dull appearance in galvanized products. The top rail (left) has a winding pattern of dull gray areas corresponding to the

Gray Coating due to Processing

process used during the making of the tube. The stresses in the steel from processing affect the intermetallic formation and can result in this striped look. The corrosion protection is not affected thus these parts are

acceptable according to the specification.

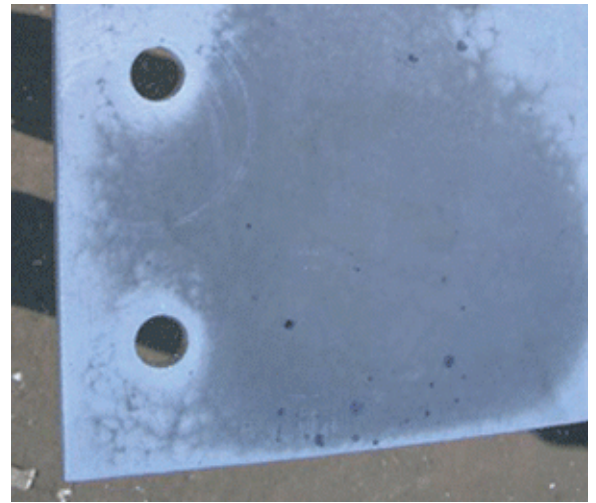
A steel part with both dull and shiny coating can also be the result of a different cooling rate. In the example, (right) the outer edges of the product were cooled rapidly, allowing a free zinc layer to form on top of the intermetallic layers. The center of the product remained above 550 F longer and the metallurgical reaction between zinc and iron continued in the solid state consuming the free zinc layer, resulting in a matte gray look. As the product weathers, the differences in appearance will become less noticeable and/or disappear and will turn a uniform, matte gray throughout.

Grey Coating Due to Temperature Differences

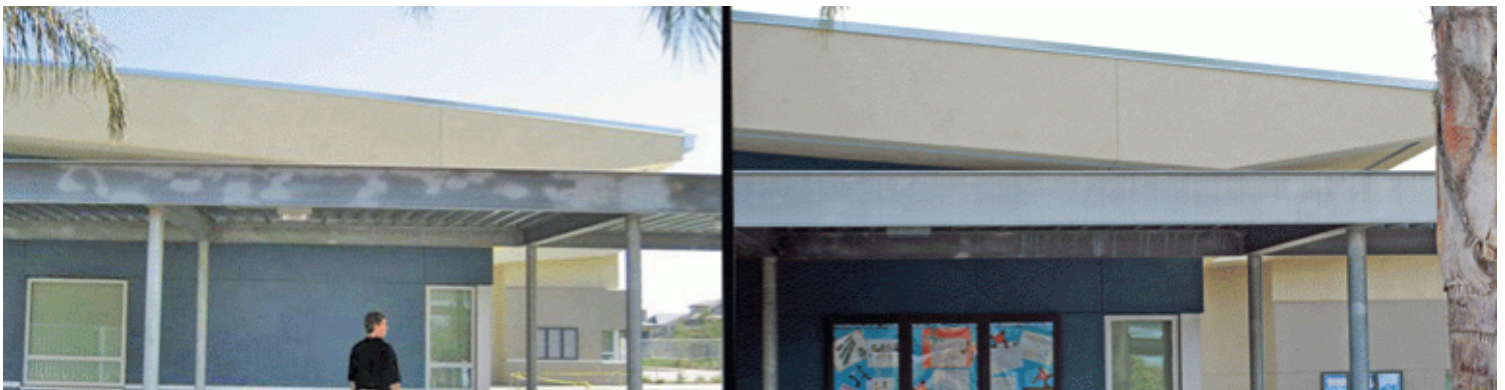
Regardless of the initial coating appearance, over time as the galvanized steel weathers, variances in appearance will fade and the coating will become a uniform matte gray. When exposed to the atmosphere, galvanized steel naturally develops a protective zinc patina on the surface which provides the uniform soft gray appearance.

The time required for the change in appearance to occur is dependent on the exposure conditions. A great example of the transformation is the canopied walkway at Mark Twain Elementary in Riverside, CA. The original canopies installed had coating variances bright and shiny on the same beam. After a few years, the structure was revisited to check the performance and the difference in appearance had evened out to a uniform matte gray.
